A computed tomographic and pathological study of equine cheek teeth infundibulae extracted from asymptomatic horses. Part 2: MicroCT, gross and histological findings

A Computed Tomographic and Pathological Study of Equine Cheek Teeth Infundibulae Extracted From Asymptomatic Horses. Part 2: MicroCT, Gross, and Histological Findings

Apryle Horbal, Sionagh Smith and Padraic M. Dixon*

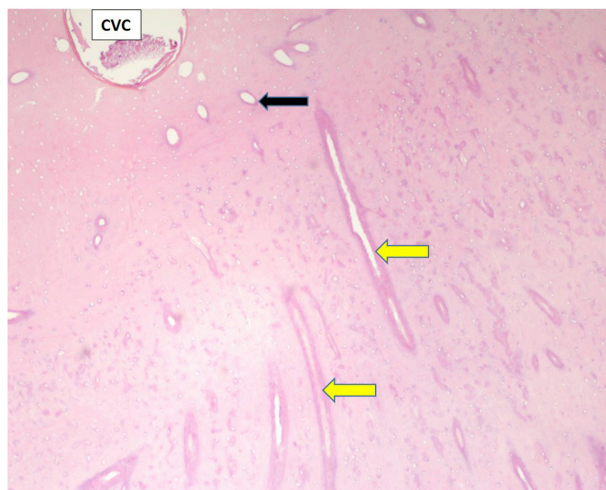
FIGURE 1 | Transverse histological section of part of a grossly normal infundibulum. A small, round central vascular channel (CVC) at top left of image contains small amounts of degraded cementum. This infundibulum is filled with relatively dense cementum containing empty, relatively small, mainly transversely oriented lateral branches from the CVC (yellow arrows) but also some more vertically, and obliquely oriented small lateral branches (black arrow). (H&E; x 40 magnification when image is 140 mm wide).

A transverse histological section of a grossly normal infundibulum with a “normal” central vascular channel from a control tooth (no infundibular caries or subocclusal cemental defect) is shown in **Figure 1**. An example of a histological image of a food debris-filled, central linear cemental defect (linear defect wider than a “normal” central vascular channel) as described in an accompanying article (8) but without surrounding cemental caries is shown in **Figure 2**.

Histological examinations showed that normal cementum had limited numbers of small side channels branching off the central vascular channel (**Figures 1, 6–8**). In contrast, areas of hypointense cementum contained higher numbers of much wider channels branching off the consistently present “central” vascular channel that was not always centrally positioned (**Figures 2–5, 11**). These lateral channels appeared to be the sites of former lateral branches of the large central blood vessel that supported cementum deposition more peripherally that were not replaced with cementum during development. Some such areas had a dense, smooth bordered central vascular channel, and side branches which, even though they often contained food material, had minimal evidence of carious destruction (**Figure 2**). However, if the horses had lived longer, it is likely that bacterial degradation of this cementum, i.e., caries would have occurred. Larger areas completely devoid of cementum (or plant material) were recognized both apically and centrally, sometimes containing fibrillar, collagenous-type material, possibly remnants of the enamel organ, and/or the dental follicle tissue (3) (e.g., **Figures 5, 10, 11**) indicative of developmental cemental hypoplastic defects.

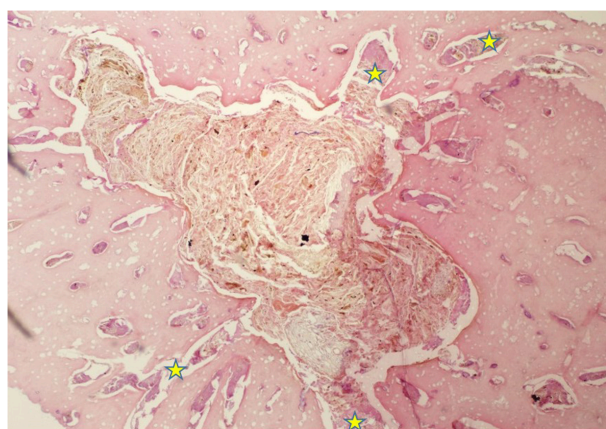
FIGURE 2 | H&E stained transverse section of a central, longitudinally-oriented, subocclusal cemental defect of a rostral infundibulum that had occlusal caries. The image highlights a triangular cemental defect (central vascular channel) tightly packed with plant material, and surrounded by histologically normal cementum, with well-defined margins, indicating that this was a developmental rather than carious cemental defect. Some food material and minimal amounts of cellular debris and cemental fragments are also present in many smoothly-outlined, horizontally oriented lateral channels (yellow stars) branching off the central defect. Under the appropriate conditions, this deeper area of the infundibulum would later have developed caries (H&E; x 40 magnification when image is 140 mm wide).

Some areas of porous cementum, even deep within the infundibulum (**Figure 2**) without obvious caries, were filled with plant material that likely was the cause of much of the discolored carious cementum, but some hypoplastic areas without any occlusal connection (and thus not containing detectable food) also had strands of a basophilic collagenous-type material (**Figures 6, 7**). The grossly apparent, dark staining in these areas (**Figures 6, 7**) did not appear to be of bacterial or food origin, and was possibly due to residual porphyrin from the previous blood supply (7). Carious areas contained food material with disintegrating cementum in which there was loss of a well-defined central vascular channel and side branches (e.g., **Figure 4**). The most carious affected tooth (Tooth F), disintegrated during decalcification and could not be histologically examined.

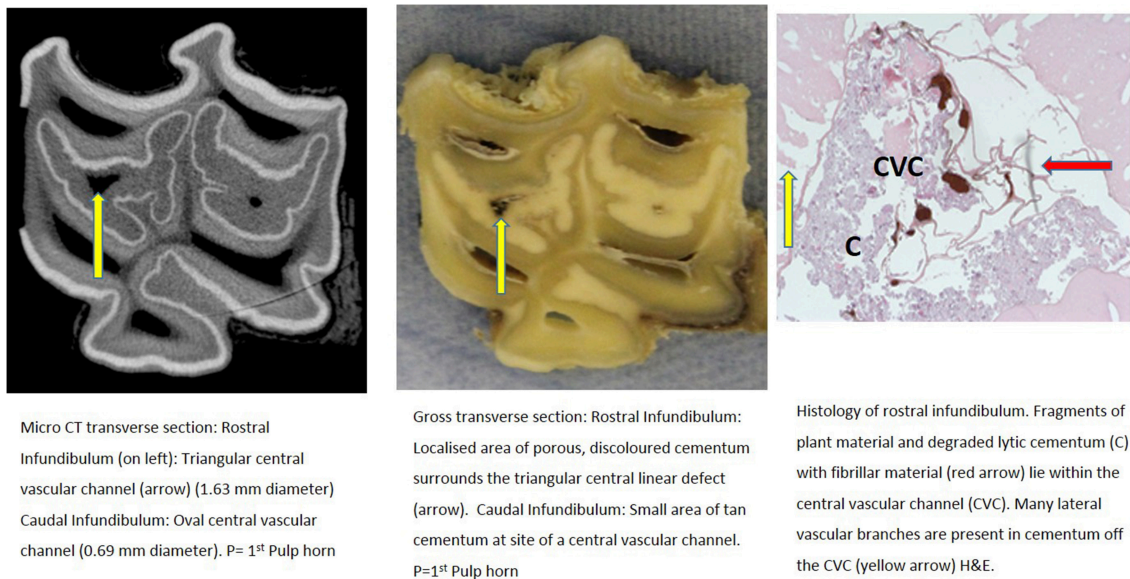
FIGURE 3 | Tooth A, 30 mm subocclusally. Transverse microCT image and gross section (both x2 magnification—editor when this image is 19.6 cm wide), and histological section (H&E, x10 magnification). The rostral (mesial) infundibulum lies on the left of the microCT and gross section images.

Subocclusal sections that appeared to have areas of almost total cemental hypoplasia on microCT with marked hypointensity had corresponding grossly recognizable defective or absent cementum at these same sites (e.g., **Figures 3, 9, 10**). However, other microCT images showed areas of marked cemental hypointensity that were larger than the lesions observed on gross and histological sections (**Figures 4, 7, 8**).

Infundibular cementum with caries and containing food material, e.g., the rostral infundibulum of tooth A 30 mm subocclusally (**Figure 3**) had a HU value of 99, whilst at

Some infundibulae had expansion of “normal” sized occlusal defects in an apical direction (as shown between **Figures 3, 4** and between **Figures 8, 9**) a feature also noticed on standard CT imaging in a companion study (8). Despite having relatively “normal” sized occlusal defects, some of these infundibulae had food penetration into the deeper attached cemental defects (e.g., **Figure 8**). Due to the prolonged mastication of horses (intermittently for up to 18 h/day) with massive masticatory occlusal pressures (of up to 2,000 Newtons) (17) it appears that even the smallest “normal” occlusal defects can have food deeply impacted within them—as also occurs with narrow, valve-shaped cheek teeth diastemata (18). This finding further raises the question of what could be considered normal, in terms of dimensions of a central vascular channel.

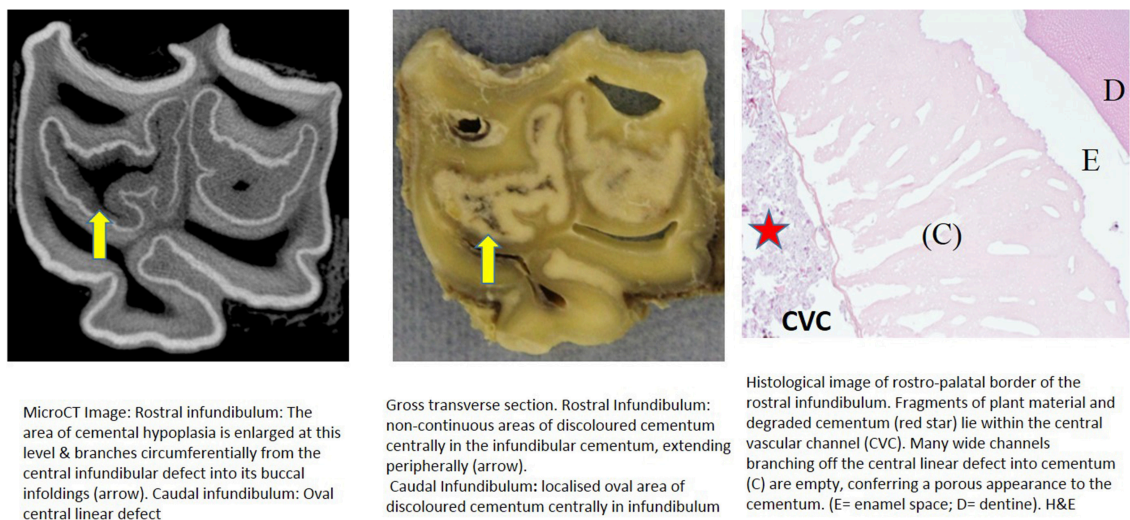
FIGURE 4 | Tooth A, 40 mm subocclusally. Transverse microCT image and gross section (both x2 magnification—editor when image is 19.6 cm wide) and histological section (H&E, x 10 magnification). The rostral (mesial) infundibulum lies on the left of the microCT and gross section images.

40 mm subocclusally (**Figure 4**) this infundibulum had a HU value of 22. Tooth E, 15 mm subocclusally (**Figure 11**) had less severe carious changes in its rostral infundibulum with

Some microCT images showed areas of marked cemental hypointensity that were larger than the lesions observe on gross and histological sections (Figures 4, 8, 9). In these infundibulae, some hypointense cemental areas that appeared to be completely devoid of cementum on MicroCT imaging were histologically found to contain very porous, likely minimally calcified cementum (Figures 4, 8, 9). However, cementum with reduced calcification would not be identified histologically, because all calcified tissues are fully removed during histological preparation. Additionally, the HU values of these hypointense areas also confirmed that they were not completely devoid of tissue, showing that CT can overestimate the size of cemental lesions.

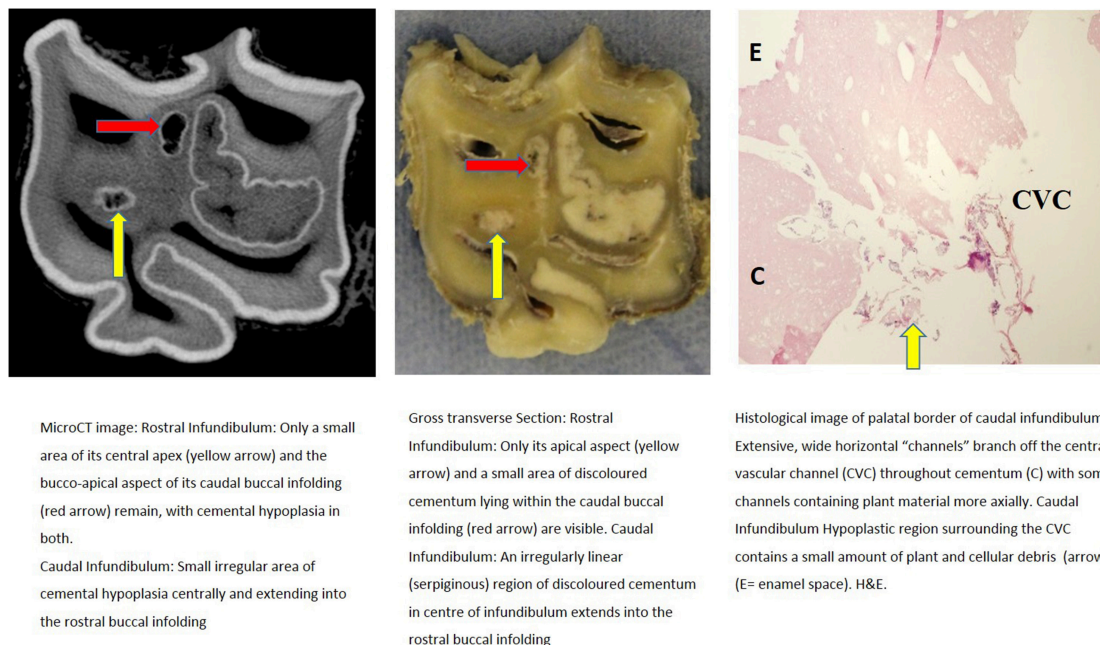
FIGURE 5 | Tooth A, 55 mm subocclusally. Transverse microCT image and gross section (both x2 magnification—editor when image is 19.6 cm wide) and histological section (H&E, x 10 magnification). The rostral (mesial) infundibulum lies on the left of the microCT and gross section images.

Most infundibulae in this study contained extensive, lateral horizontal branches off the central vascular channel, which varied in number and size, and from being empty; filled with collagenous debris, food material, or degraded cementum; or combinations of these. It would appear that normal appearing cementum with low numbers of small lateral branches (e.g., **Figures 1, 6**) has the highest density (up to 3,725 HU) whilst cementum with more extensive and larger lateral branching is less dense (as low as 2,029 HU) as was found in deeper normal cementum (55 mm subocclusally) in **Figure 5**.

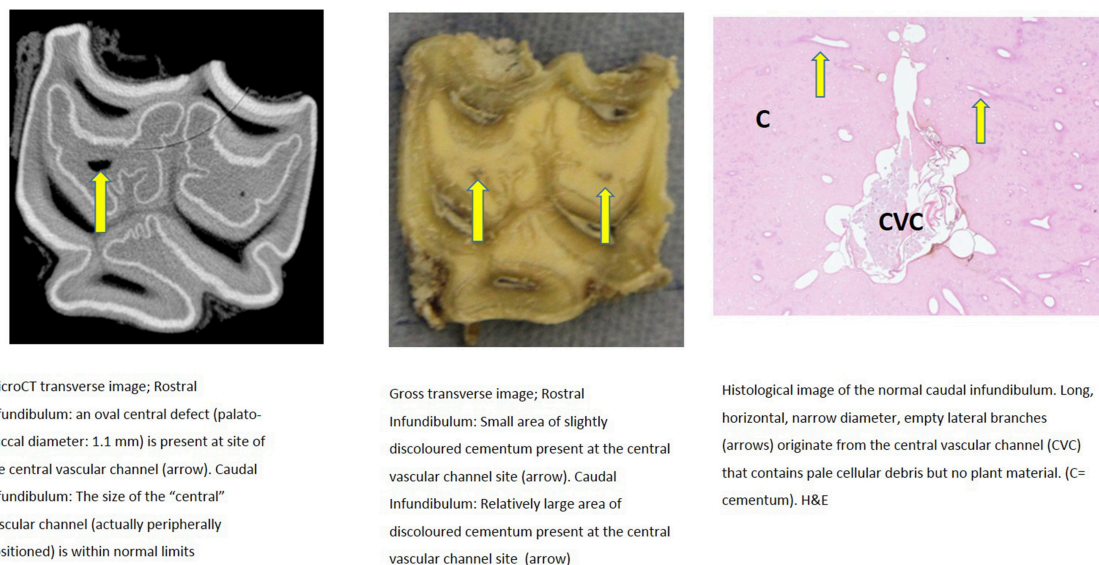
FIGURE 6 | Tooth B, 20 mm subocclusally. Transverse microCT image and gross section (both x2 magnification—editor when image is 19.6 cm wide) and histological section (H&E, x 9 magnification). The rostral (mesial) infundibulum lies on the left of the microCT and gross section images.

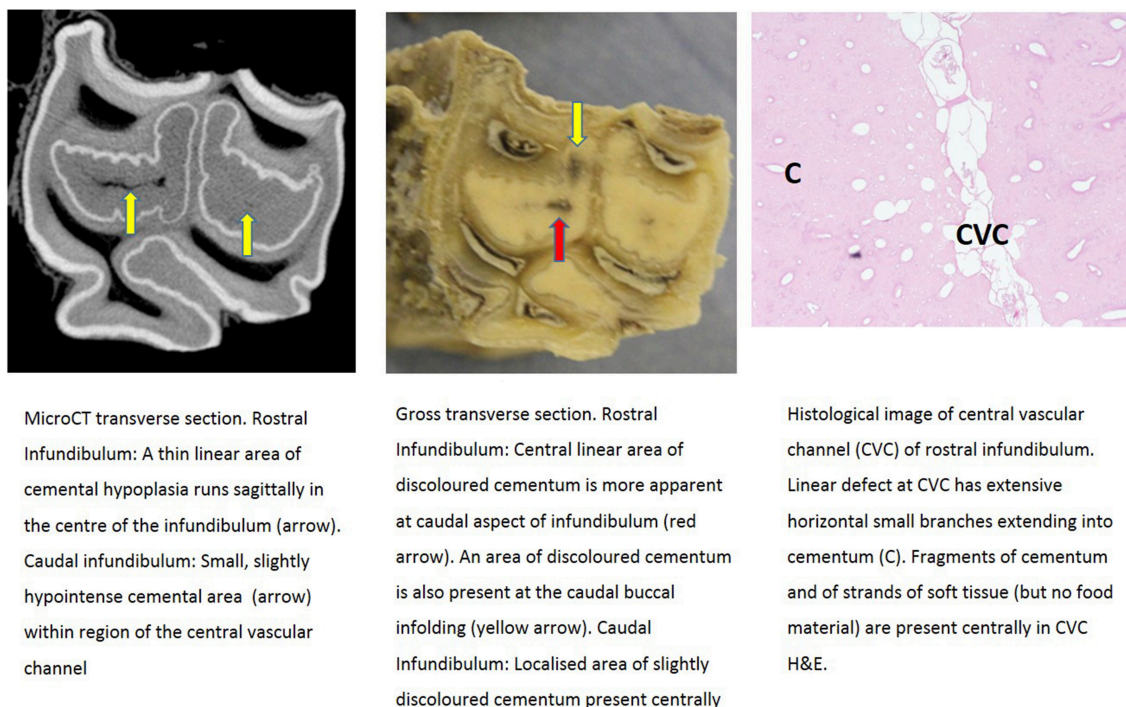
FIGURE 7 | Tooth B, 50 mm subocclusally. Transverse microCT image and gross section (both x2 magnification—editor when image is 19.6 cm wide) and histological section (H&E, x 10 magnification). The rostral (mesial) infundibulum lies on the left of the microCT and gross section images.

infundibulum of tooth B, 50 mm subocclusally—**Figure 7**) were histologically noted to have small, well-defined central vascular channels and side branches such as shown in **Figures 1, 6–8**. More occlusal cementum in six infundibulae had a median HU value of 3,601, while 22 mm more apically it had a lower value of 3,196, indicating an age-related decrease in (more apically situated) cementum.

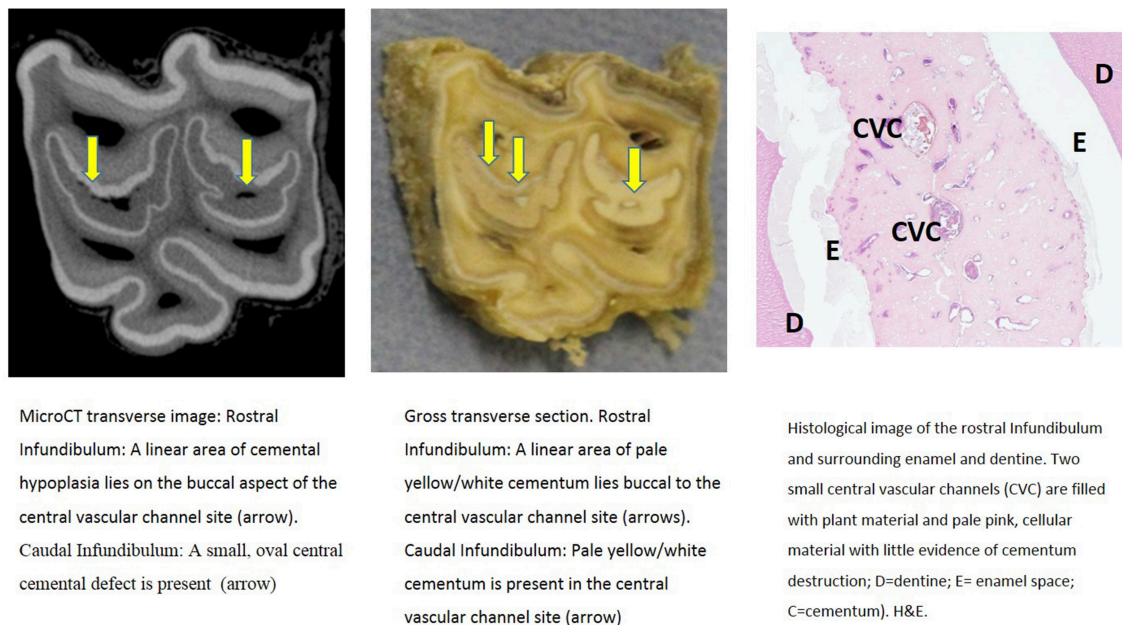
FIGURE 8 | Tooth C, 15 mm subocclusally. Transverse microCT image and gross section (both x2 magnification—editor when image is 19.6 cm wide) and histological section (H&E, x 4.5 magnification). The rostral (mesial) infundibulum lies on the left of the microCT and gross section images.

degree of cemental hypoplasia ($n = 5$ sites) anatomically and on microCT imaging including the caudal infundibulum of tooth C, 15 mm subocclusally (Figure 8) that had a HU of 1,132, whilst its rostral infundibulum with more marked hypoplasia had a HU value of 475 (Figure 8).

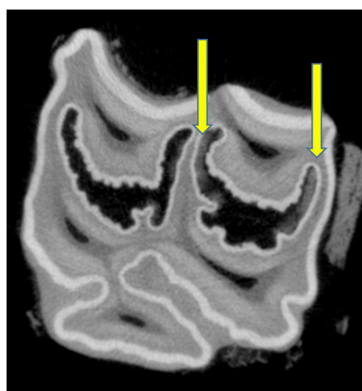
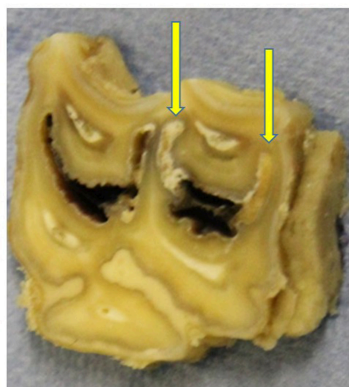
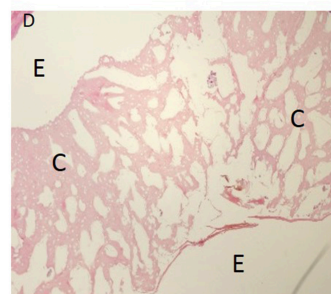
MicroCT transverse image. Rostral Infundibulum: Almost complete cemental hypoplasia, with miniscule areas of residual hypointense cementum in the caudal buccal infolding. **Caudal Infundibulum:** Marked central cemental hypoplasia; some hypointense cementum remaining in buccal infoldings (arrows). Palato-buccal width of infundibular defect: 3.56 mm

Gross transverse image. Rostral Infundibulum: Total cemental hypoplasia, except in caudal buccal infolding; some discolouration of the surrounding enamel (that appeared normal on CT). **Caudal Infundibulum:** Complete cemental hypoplasia of centre of infundibulum with adjacent enamel discoloured. Some discoloured cementum remains in both buccal infoldings (arrows)

Histological image of caudal infundibular buccal infolding. Cementum (C) has a marked, irregular moth-eaten appearance, but without the presence of food (caries), dissimilar to the regular cylindrical defects present at former vasculature sites. Small basophilic cemental pockets contain a basophilic acellular material. Darker pink strands of collagen-like material present (at bottom of image) (E= enamel; D= dentine). H&E.

FIGURE 9 | Tooth C, 30 mm subocclusally. Transverse microCT image and gross section (both x2 magnification—editor when image is 19.6 cm wide) and histological section (H&E, x 10 magnification). The rostral (mesial) infundibulum lies on the left of the microCT and gross section images.

Cemental caries was sometimes accompanied by disrupted vascular channel architecture, i.e., with carious destruction and thus irregularity of the usually well-defined cylindrical vascular site walls by caries (Figures 4, 9). Whilst some cemental defects contained some food particles (e.g., Figures 3, 4, 8) it is likely that most intra-infundibular food material was lost during decalcification and histological preparation.

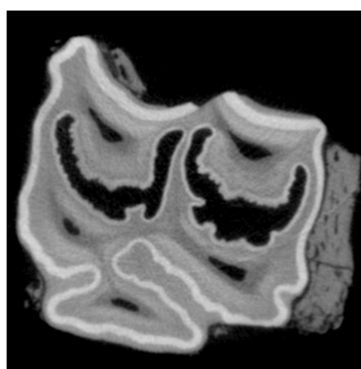
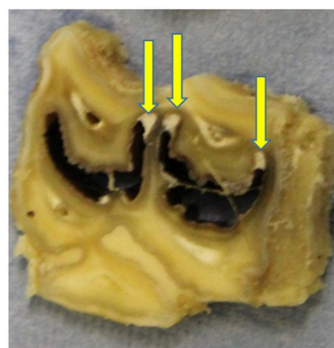
MicroCT transverse image. Rostral Infundibulum: Complete cemental hypoplasia and slight hypointensity of surrounding enamel. **Caudal Infundibulum:** Complete cemental hypoplasia and some hypointensity of surrounding enamel

Gross transverse image. Rostral Infundibulum: Almost complete cemental hypoplasia (except in caudal, buccal infoldings – not seen on CT-arrow) and discolouration of infundibular enamel. **Caudal Infundibulum:** Almost complete central cemental hypoplasia (except in buccal infoldings with small areas of cementum not seen on CT-arrows). Strands of soft tissue remnants centrally and discolouration of surrounding enamel

Histological Image of caudal infundibular amelocemental junction. The infundibular defect contains strands of fibrillated, degenerated material. The limited cemental remnants (C) appear to be peeling away from the amelocemental junction. No food material, i.e. no contact with occlusal surface, and thus caries is present. D= dentine, E= enamel). H&E

FIGURE 10 | Tooth D, 30 mm subocclusally. Transverse microCT image and gross section (both x2 magnification—editor when image is 19.6 cm wide) and histological section (H&E, x 10 magnification). The rostral (mesial) infundibulum lies on the left of the microCT and gross section images.

six teeth at different subocclusal levels. Cemental density could not be assessed in Tooth D (**Figure 10**) that had gross cemental hypoplasia/aplasia or in a Tooth F with marked caries and no cementum.

Cementum with gross hypoplasia/aplasia ($n = 4$ sites) as shown in both infundibulae in Figure 10 (i.e., Tooth

D 30 mm subocclusally) had a HU value of -396 for its rostral infundibulum that contained cementum of moth-eaten appearance with basophilic pockets of mineralization. Its caudal infundibulum containing just stands of collagen-like tissue had an even lower HU value of -560 . At a more apical level (image not shown) this caudal infundibular cement had the least dense area recorded (-692 HU).

a HU value of 1,265 HU and unusually, a lower density of 717 in its *caudal* infundibulum. The tooth most severely affected with caries contained just necrotic food material in its infundibulae with no cementum available for measurement (Figure 10).

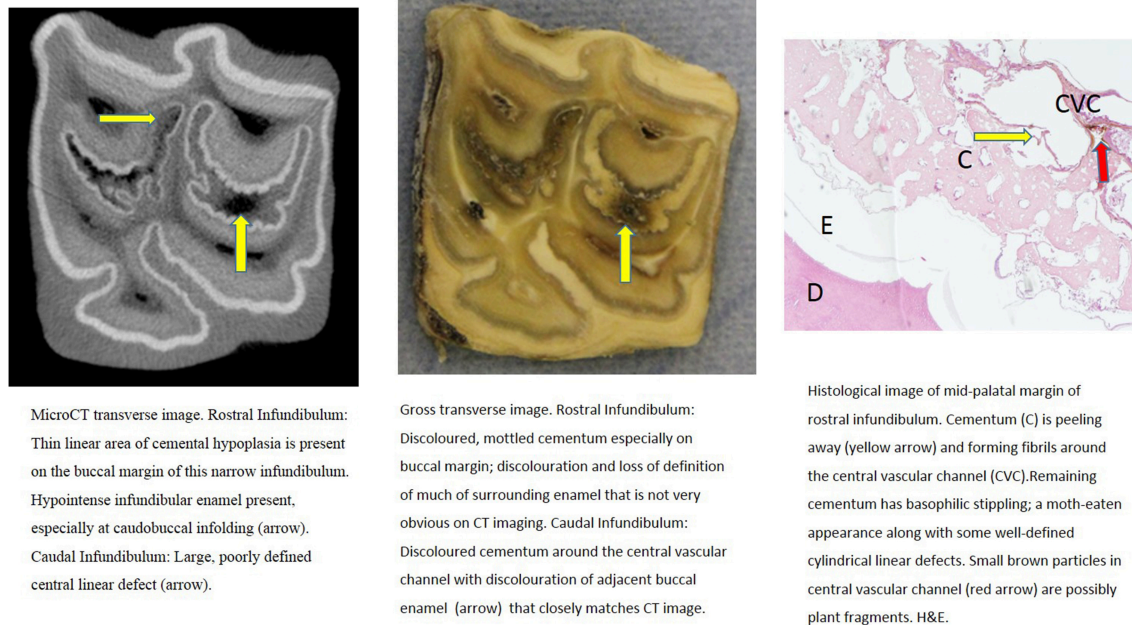
FIGURE 11 | Tooth E, 15 mm subocclusally. Transverse microCT image and gross section (both x2 magnification—editor when image is 19.6 cm wide) and histological section (H&E, x 10 magnification). The rostral (mesial) infundibulum lies on the left of the microCT and gross section images.

Because all enamel is removed during decalcification of specimens just leaving an empty “enamel space,” the enamel changes seen on microCT and gross sections (e.g., Figures 10, 11) could not be assessed histologically in these specimens. Kilic et al. (1) histologically described abnormal infundibular cemental architecture, similar to the hypoplastic cementum findings in
